JAY LITTLETON BALL PARK HISTORIC STRUCTURE REPORT

ONTARIO, CALIFORNIA

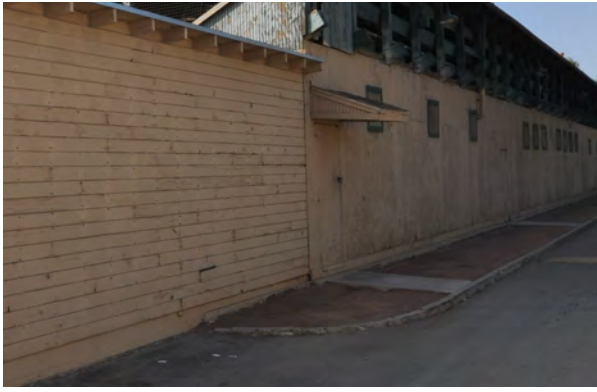
| TYPE | FEATURE | PHOTO (IF APPLICABLE) | IMPORTANCE: REASON | CONDITION |
|---|--|--|---|--|
| | <p>Secondary Entrance Openings</p> <ul style="list-style-type: none"> • First story • Grandstand street-facing elevation • Two openings on south wing, one off center to the south and one at south end • Two openings on east wing, one at center and one off center to east • Rectangular opening • Wood frame | | <p>Primary: Dates from the period of significance, highly visible, and retains overall integrity.</p> | <p>Fair Condition</p> <ul style="list-style-type: none"> • Cracking and checking observed at wood frames |

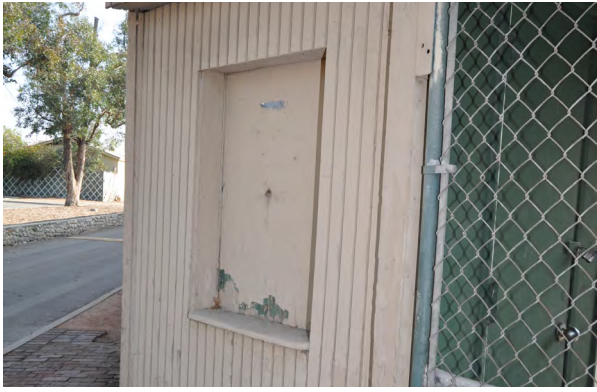
| TYPE | FEATURE | PHOTO (IF APPLICABLE) | IMPORTANCE: REASON | CONDITION |
|---|--|--|---|--|
| | <p>Ticket Window Openings</p> <ul style="list-style-type: none"> • First story • Grandstand street-facing elevation • Flanking main entrance • Rectangular opening • Wood frame | | <p>Primary: Dates from the period of significance, highly visible, and retains overall integrity.</p> | <p>Fair Condition</p> <ul style="list-style-type: none"> • Mechanical damage observed at wood frames |

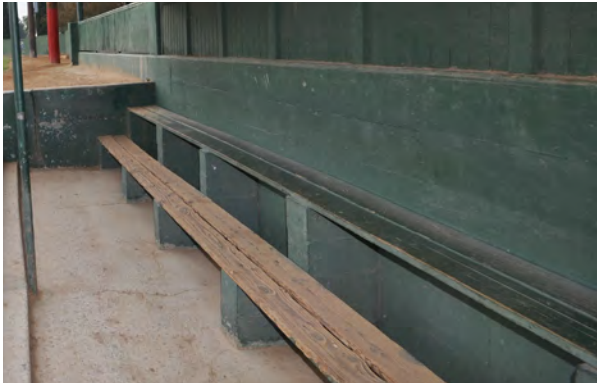
| TYPE | FEATURE | PHOTO (IF APPLICABLE) | IMPORTANCE: REASON | CONDITION |
|---|---|--|--|--|
| EXTERIOR MATERIALS AND CRAFTSMANSHIP | Board-Formed Concrete <ul style="list-style-type: none"> • First story • Grandstand field-facing elevation • Retaining wall | | Primary: Dates from the period of significance, highly visible, and retains overall integrity. | Fair Condition <ul style="list-style-type: none"> • Peeling and deteriorating paint observed throughout • Scaling of the concrete surface observed at select locations • Cracking and spalling observed at select locations |

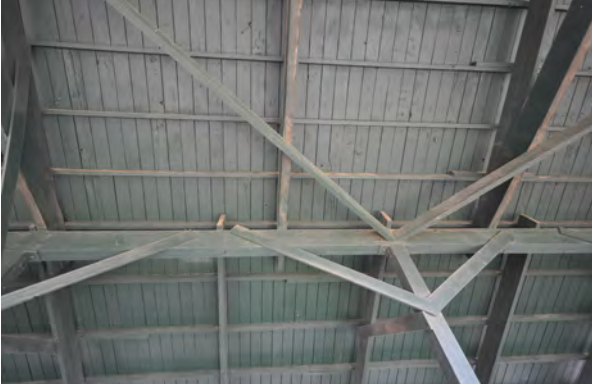
| TYPE | FEATURE | PHOTO (IF APPLICABLE) | IMPORTANCE: REASON | CONDITION |
|---|---|--|--|--|
| EXTERIOR MATERIALS AND CRAFTSMANSHIP | Grandstand Roof <ul style="list-style-type: none"> • Sheathing • Wood | | Primary: Dates from the period of significance, highly visible, and retains overall integrity. | Fair Condition <ul style="list-style-type: none"> • Peeling and deteriorating paint observed throughout • Cracking and checking observed at select locations • Severe cracking observed at select locations, most notably at locations of metal nails |

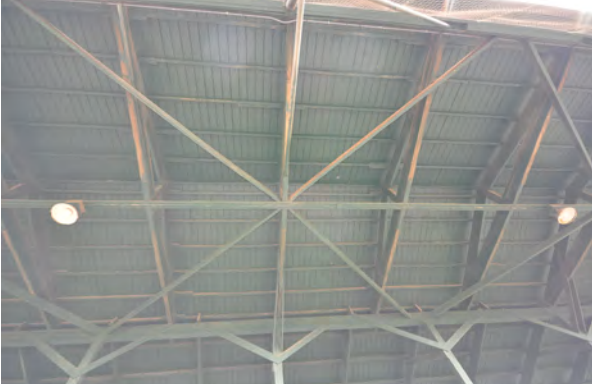
| TYPE | FEATURE | PHOTO (IF APPLICABLE) | IMPORTANCE: REASON | CONDITION |
|---|---|--|--|--|
| | Grandstand Roof Trusses <ul style="list-style-type: none"> • Exposed beams • Wood | | Primary: Dates from the period of significance, highly visible, and retains overall integrity. | Fair to Poor Condition <ul style="list-style-type: none"> • Peeling and deteriorating paint observed throughout • Weathering observed throughout • Checking and cracking observed at select locations • Severe cracking observed at select locations, most notably at locations of metal bolts |

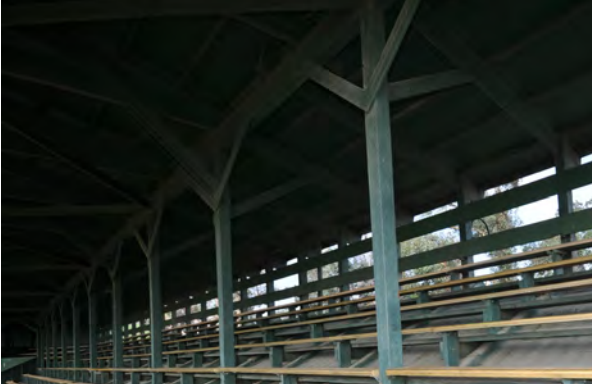
| TYPE | FEATURE | PHOTO (IF APPLICABLE) | IMPORTANCE: REASON | CONDITION |
|---|---|--|--|--|
| | Grandstand Roof Square Columns <ul style="list-style-type: none"> • All elevations • Center, south, and east wings • Wood post • Concrete footing | | Primary: Dates from the period of significance, highly visible, and retains overall integrity. | Fair to Poor Condition <ul style="list-style-type: none"> • Peeling and deteriorating paint observed throughout • Weathering observed throughout • Checking and cracking observed at select locations • Severe cracking observed at select locations, most notably at locations of metal bolts |

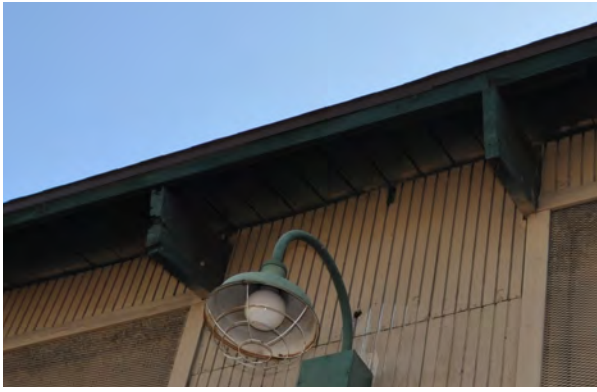
| TYPE | FEATURE | PHOTO (IF APPLICABLE) | IMPORTANCE: REASON | CONDITION |
|---|---|---|--|--|
| | Grandstand Roof Fascia Board <ul style="list-style-type: none"> • All elevations • Wood | | Primary: Dates from the period of significance, highly visible, and retains overall integrity. | Fair Condition <ul style="list-style-type: none"> • Peeling and deteriorating paint observed throughout • Cracking and checking observed throughout |
| | Grandstand Roof Exposed Rafter Tails <ul style="list-style-type: none"> • All elevations • Wood | (See Above) | Primary: Dates from the period of significance, highly visible, and retains overall integrity. | Fair to Poor Condition <ul style="list-style-type: none"> • Peeling and deteriorating paint observed throughout • Cracking, checking, and material loss observed at select locations |

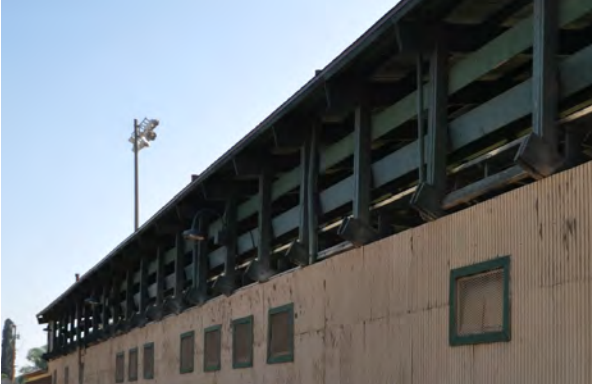
| TYPE | FEATURE | PHOTO (IF APPLICABLE) | IMPORTANCE: REASON | CONDITION |
|---|--|--|--|---|
| EXTERIOR MATERIALS AND CRAFTSMANSHIP | Grandstand Street-Facing Elevation Original Guard Rail <ul style="list-style-type: none"> • Second story • South and east wings • Lower guard rail • Wood | | Primary: Dates from the period of significance, highly visible, and retains overall integrity. | Fair to Poor Condition <ul style="list-style-type: none"> • Cracking and checking observed throughout • Cracking notably observed at locations of nails • Severe cracking observed at select locations, most notably at locations of metal nails |

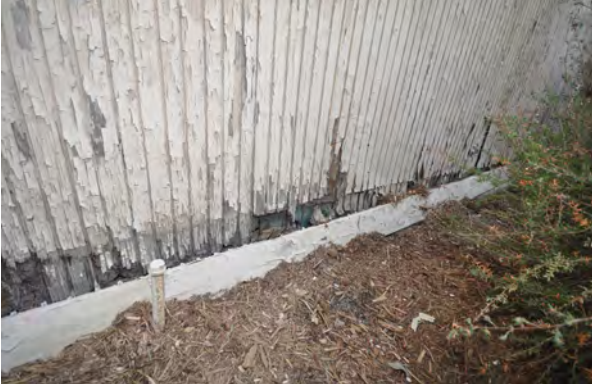
| TYPE | FEATURE | PHOTO (IF APPLICABLE) | IMPORTANCE: REASON | CONDITION |
|---|--|--|--|---|
| | Grandstand Street-Facing Elevation Siding <ul style="list-style-type: none"> • Center, south, and east wings • Beadboard • Wood | | Not: Post dates period of significance. | Poor Condition <ul style="list-style-type: none"> • Original wood plank siding likely covered by non-original beadboard siding • Cracking and checking observed throughout • Erosion or total loss of material was notably observed along the bottom of the siding adjacent to the baseboard |

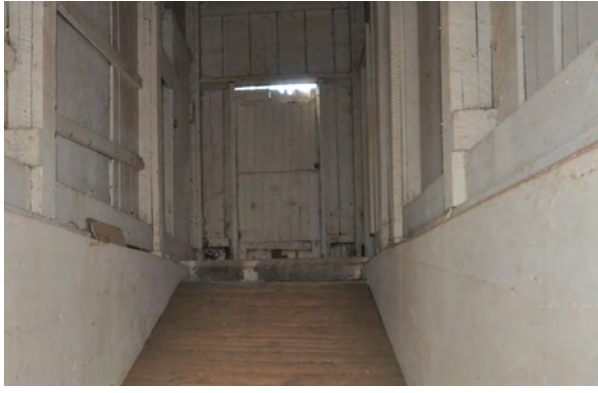
| TYPE | FEATURE | PHOTO (IF APPLICABLE) | IMPORTANCE: REASON | CONDITION |
|---|--|--|---|--|
| EXTERIOR MATERIALS AND CRAFTSMANSHIP | Grandstand Street-Facing Elevation Original Secondary Entrance Doors <ul style="list-style-type: none"> • First story • South and east wings • Located at entrances to locker room tunnels • Wood plank doors covered with beadboard siding | | Secondary: Dates from the period of significance and highly visible, but altered since the end of the period of significance. | Poor Condition <ul style="list-style-type: none"> • Non-original beadboard siding appears to cover original wood plank at secondary entrance doors to locker room tunnels • Cracking and checking observed throughout • Erosion or total loss of material was notably observed along the bottom |

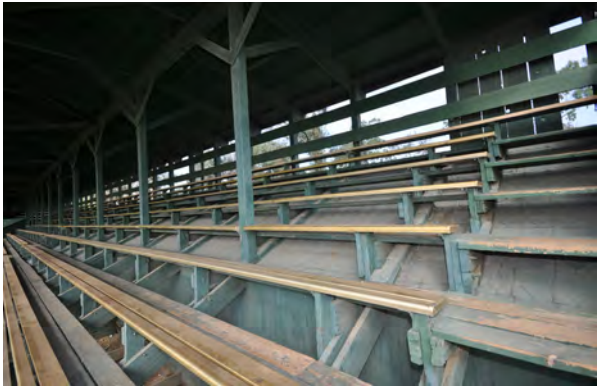
| TYPE | FEATURE | PHOTO (IF APPLICABLE) | IMPORTANCE: REASON | CONDITION |
|---|---|--|--|--|
| EXTERIOR MATERIALS AND CRAFTSMANSHIP | Grandstand Field-Facing Elevation Grandstand Tiered Platforms <ul style="list-style-type: none"> • First and second stories • South and east wings • Wood | | Primary: Dates from the period of significance, highly visible, and retains overall integrity. | Fair to Poor Condition <ul style="list-style-type: none"> • Peeling and deteriorated paint observed throughout • Weathering observed throughout • Cracking and checking observed throughout • Severe cracking notably observed at locations of nails |

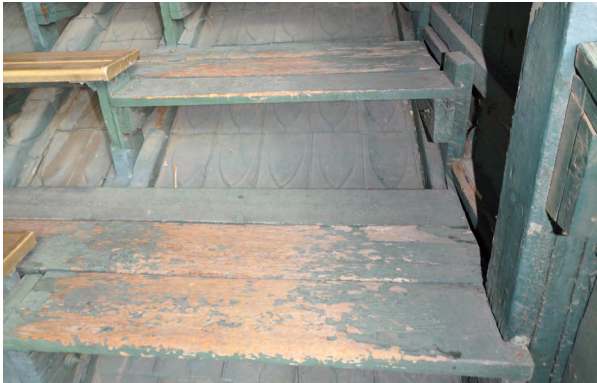
| TYPE | FEATURE | PHOTO (IF APPLICABLE) | IMPORTANCE: REASON | CONDITION |
|---|---|--|--|--|
| | Grandstand Field-Facing Elevation Grandstand Steps <ul style="list-style-type: none"> • First and second stories • South and east wings • Wood | | Primary: Dates from the period of significance, highly visible, and retains overall integrity. | Fair to Poor Condition <ul style="list-style-type: none"> • Original steps selectively removed and replaced in kind • Peeling and deteriorating paint observed throughout • Weathering observed throughout • Cracking and checking observed throughout • Severe cracking notably observed at locations of nails |

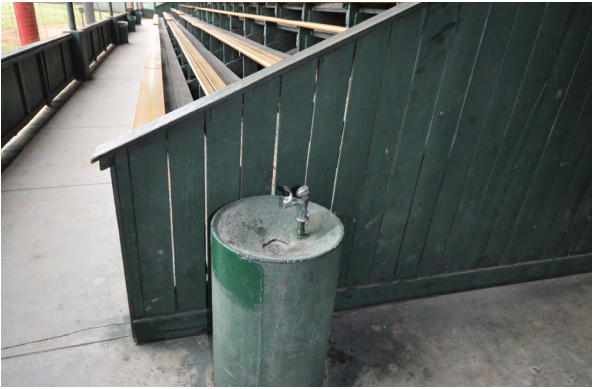
| TYPE | FEATURE | PHOTO (IF APPLICABLE) | IMPORTANCE: REASON | CONDITION |
|---|---|--|--|---|
| EXTERIOR MATERIALS AND CRAFTSMANSHIP | Grandstand Field-Facing Elevation Wood Plank Siding <ul style="list-style-type: none"> • First and second stories • South and east wings • Wood plank | | Primary: Dates from the period of significance, highly visible, and retains overall integrity. | Fair to Poor Condition <ul style="list-style-type: none"> • Peeling and deteriorating paint observed throughout • Weathering observed throughout • Cracking and checking observed throughout • Severe cracking notably observed at locations of nails |

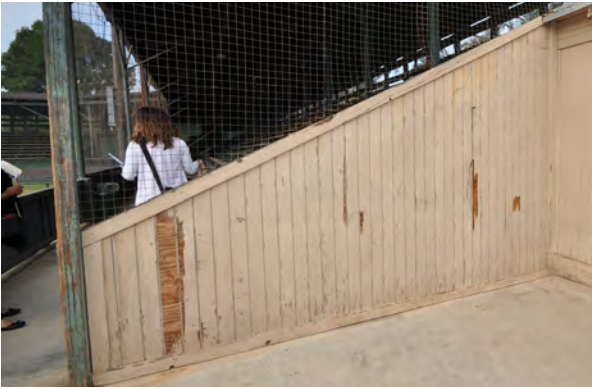
| TYPE | FEATURE | PHOTO (IF APPLICABLE) | IMPORTANCE: REASON | CONDITION |
|---|---|--|--|---|
| | Grandstand Field-Facing Elevation Beadboard Siding <ul style="list-style-type: none"> • First and second stories • East wing • Wood | | Not: Post dates period of significance. | Fair to Poor Condition <ul style="list-style-type: none"> • Peeling and deteriorating paint observed throughout • Checking and material loss observed throughout |

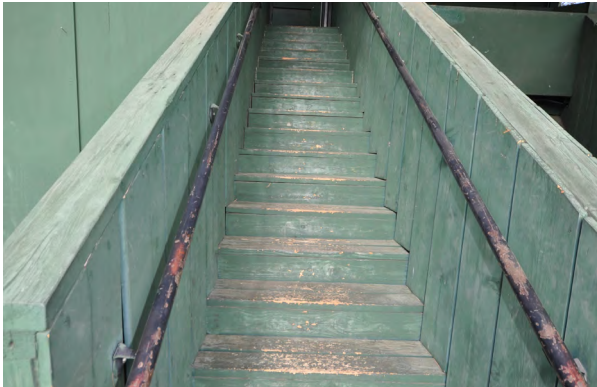
| TYPE | FEATURE | PHOTO (IF APPLICABLE) | IMPORTANCE: REASON | CONDITION |
|---|---|--|--|--|
| | Grandstand Field-Facing Elevation Press Box Stair and Railing <ul style="list-style-type: none"> • First and second stories • Center section • Wood treads and risers • Wood plank railing | | Primary: Dates from the period of significance, highly visible, and retains overall integrity. | Fair Condition <ul style="list-style-type: none"> • Peeling and deteriorating paint observed throughout • Weathering observed throughout • Cracking and checking observed throughout • Cracking notably observed at locations of nails |

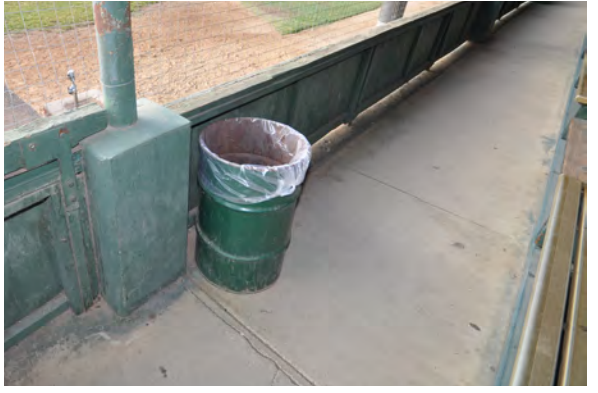
| TYPE | FEATURE | PHOTO (IF APPLICABLE) | IMPORTANCE: REASON | CONDITION |
|---|---|--|--|--|
| EXTERIOR MATERIALS AND CRAFTSMANSHIP | Grandstand Field-Facing Elevation Original Sidewalk <ul style="list-style-type: none"> • First story • Center, south, and east wings • Concrete | | Primary: Dates from the period of significance, highly visible, and retains overall integrity. | Good Condition <ul style="list-style-type: none"> • Cracking observed at select locations |

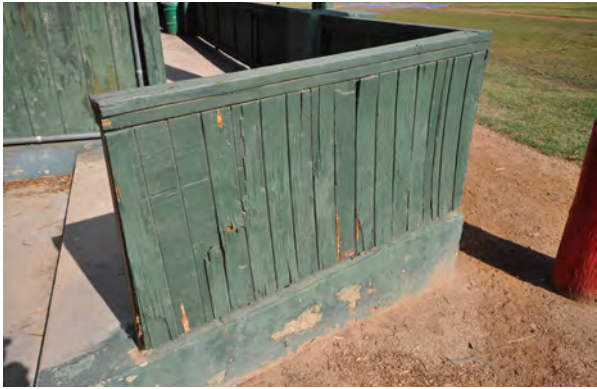
| TYPE | FEATURE | PHOTO (IF APPLICABLE) | IMPORTANCE: REASON | CONDITION |
|---|---|--|---|--|
| EXTERIOR MATERIALS AND CRAFTSMANSHIP | Grandstand Field-Facing Elevation South and East Wing Field Fence <ul style="list-style-type: none"> • First story • Wood plank or plywood, depending on location | | Secondary: Dates from the period of significance and highly visible, but altered since the end of the period of significance. | Fair to Poor Condition <ul style="list-style-type: none"> • Wood planking appears to have been replaced in select locations, possibly throughout • Cracking and checking observed throughout |

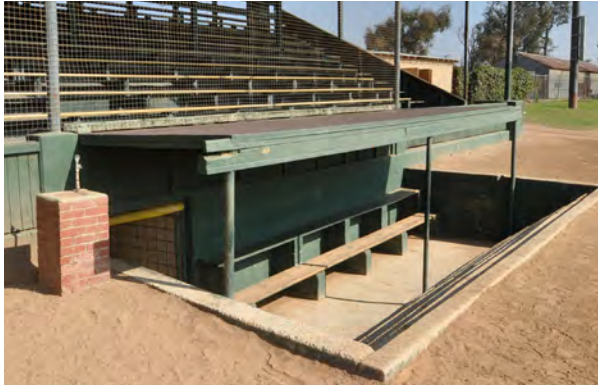
| TYPE | FEATURE | PHOTO (IF APPLICABLE) | IMPORTANCE: REASON | CONDITION |
|---|--|--|--|---|
| | Ball Field Dugout Awnings <ul style="list-style-type: none"> • Asphalt roofing material • Wood sheathing and fascia board • Metal columns | | Primary: Dates from the period of significance, highly visible, and retains overall integrity. | Fair to Poor Condition <ul style="list-style-type: none"> • Peeling and deteriorating paint observed throughout • Weathering of wood observed throughout • Cracking and checking of wood observed throughout |

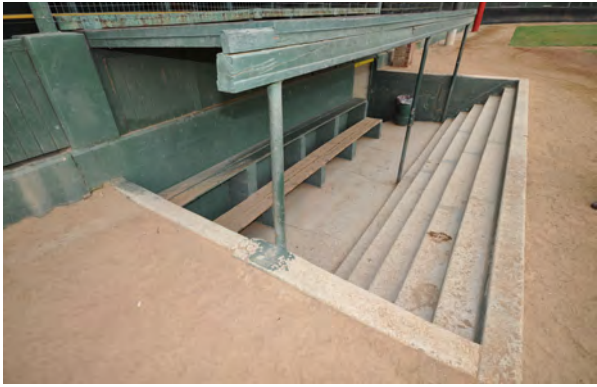
| TYPE | FEATURE | PHOTO (IF APPLICABLE) | IMPORTANCE: REASON | CONDITION |
|---|---|--|---|---|
| EXTERIOR MATERIALS AND CRAFTSMANSHIP | Ball Field Dugout Trench <ul style="list-style-type: none"> Concrete | | Secondary: Dates from the period of significance and highly visible, but altered since the end of the period of significance. | Fair Condition <ul style="list-style-type: none"> Dugout trench enlarged and non-original stairs added Scaling of the concrete surface observed |

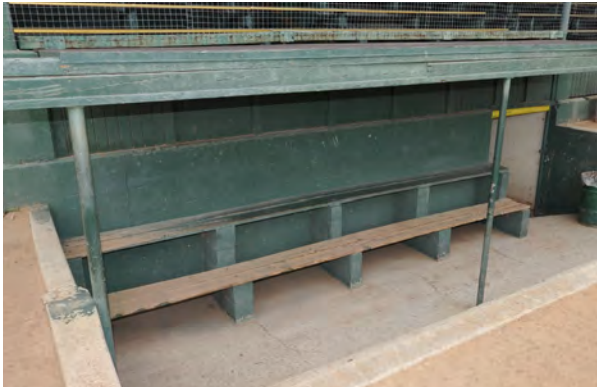
| TYPE | FEATURE | PHOTO (IF APPLICABLE) | IMPORTANCE: REASON | CONDITION |
|---|---|--|---|---|
| | Ball Field Dugout Benches <ul style="list-style-type: none"> Wood plank Concrete footings | | Primary: Dates from the period of significance, highly visible, and retains overall integrity. | Fair Condition <ul style="list-style-type: none"> Peeling and deteriorating paint observed throughout Weathering of wood observed throughout Cracking of concrete observed at select locations |

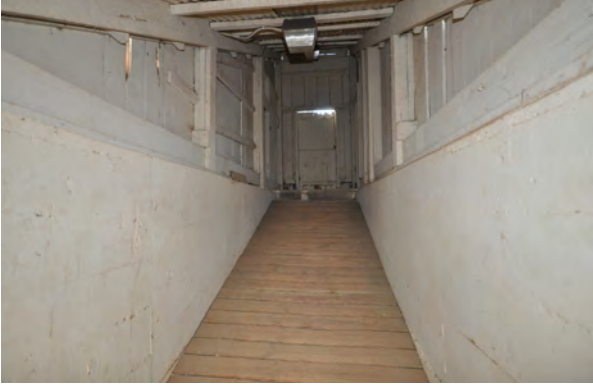
| TYPE | FEATURE | PHOTO (IF APPLICABLE) | IMPORTANCE: REASON | CONDITION |
|---|---|--|--|--|
| | Locker Room Tunnels – Space, Features, & Finishes <ul style="list-style-type: none"> • First story • Located to the north and west of the dugouts • Corrugated metal ceiling • Wood plank walls atop cement foundation • Wood plank floor | | Secondary: Dates from the period of significance and retains integrity, but not originally intended for public access. | Fair Condition <ul style="list-style-type: none"> • Weathering of wood observed throughout • Cracking and checking of wood observed at select locations • Material loss of wood planking observed at select locations |
| | Locker Rooms – Space, Features, & Finishes <ul style="list-style-type: none"> • First story • Located to the west and north of the locker room tunnels • Corrugated metal ceiling • Plywood walls • Wood locker partitions • Concrete floor | | Secondary: Dates from the period of significance and retains integrity, but not originally intended for public access. | Fair Condition <ul style="list-style-type: none"> • Non-original plywood walls added • Weathering of wood observed throughout • Cracking and checking observed at select locations • Material loss observed at plywood walls • Missing, loose, and displaced elements of lockers observed at select locations |

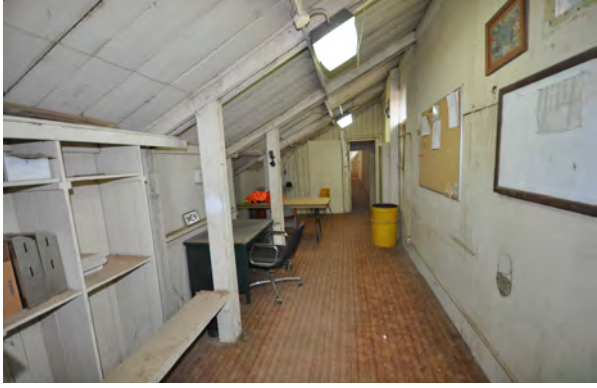
| TYPE | FEATURE | PHOTO (IF APPLICABLE) | IMPORTANCE: REASON | CONDITION |
|--|--|---|---|--|
| <p style="writing-mode: vertical-rl; transform: rotate(180deg);">INTERIOR SPACES, FEATURES, AND FINISHES</p> | <p>Manager's Office – Space, Features, & Finishes</p> <ul style="list-style-type: none"> • First story • Located at the east end of the grandstand • Wood plank ceiling • Plywood walls • Carpet floor | | <p>Secondary: Dates from the period of significance and retains integrity, but not originally intended for public access.</p> | <p>Fair to Poor Condition</p> <ul style="list-style-type: none"> • Non-original carpet and plywood walls added • Material loss at plywood walls observed at select locations |

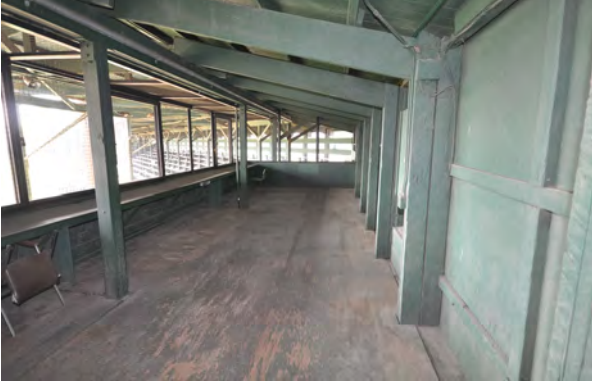
| TYPE | FEATURE | PHOTO (IF APPLICABLE) | IMPORTANCE: REASON | CONDITION |
|---|---|---|--|---|
| | Press Box – Space, Features, & Finishes <ul style="list-style-type: none"> • Second story • Located above the concession stand • Plywood walls • Rectangular opening covered by metal security gate • Plywood floors | | Secondary: Dates from the period of significance and retains integrity, but not originally intended for public access. | Fair Condition <ul style="list-style-type: none"> • Non-original metal security gate added • Weathering of wood features observed |
