JAY LITTLETON BALL PARK HISTORIC STRUCTURE REPORT

ONTARIO, CALIFORNIA

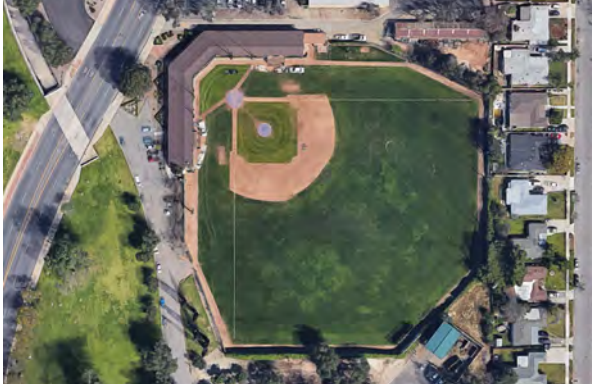
| TYPE | FEATURE | PHOTO (IF APPLICABLE) | IMPORTANCE: REASON | CONDITION |
|---|---|--|---|--|
| OVERALL VISUAL CHARACTER | <p>Immediate Setting</p> <ul style="list-style-type: none"> • Setback from the street • Brick paved paths to the north and northwest • Concrete sidewalk to the west • Planters located to the northwest and west • Utility sheds to the north and east • Asphalt paved driveways to the north and west | | <p>Primary: Dates from the period of significance, highly visible, and retains overall integrity.</p> | <p>Good Condition</p> <ul style="list-style-type: none"> • No notable conditions observed |

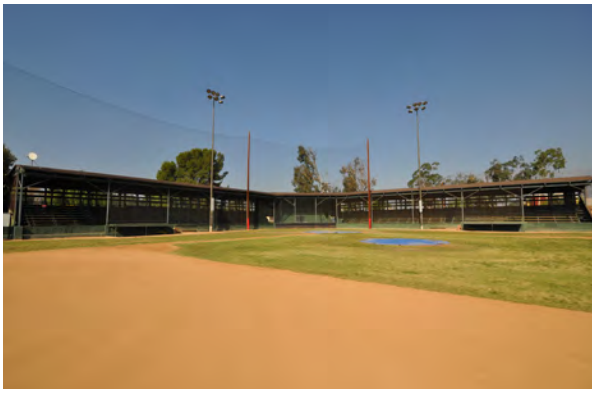
| TYPE | FEATURE | PHOTO (IF APPLICABLE) | IMPORTANCE: REASON | CONDITION |
|---|---|--|---|--|
| | <p>Massing</p> <ul style="list-style-type: none"> • U-shaped plan • Two stories • Gable roof | | <p>Primary: Dates from the period of significance, highly visible, and retains overall integrity.</p> | <p>Good Condition</p> <ul style="list-style-type: none"> • No notable conditions observed |

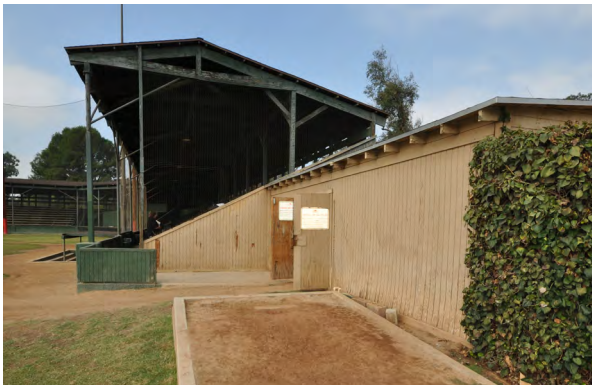
| TYPE | FEATURE | PHOTO (IF APPLICABLE) | IMPORTANCE: REASON | CONDITION |
|---|---|--|---|--|
| | <p>Roof Design</p> <ul style="list-style-type: none"> • Gable roof with an extended rear roof slope • Fascia board • Exposed rafter tails • Exposed structural members | | <p>Primary: Dates from the period of significance, highly visible, and retains overall integrity.</p> | <p>Fair to Poor Condition</p> <ul style="list-style-type: none"> • See features below for notable conditions observed at the roof |

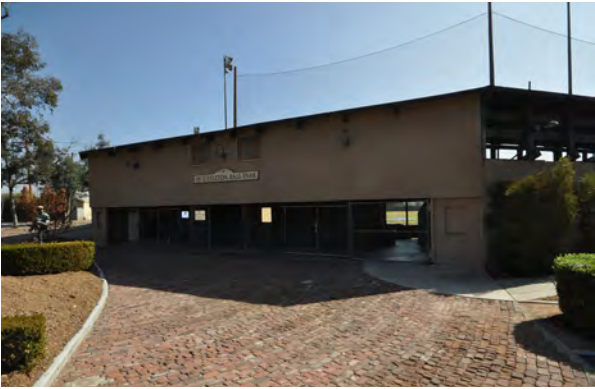
| TYPE | FEATURE | PHOTO (IF APPLICABLE) | IMPORTANCE: REASON | CONDITION |
|---|--|--|--|---|
| OVERALL VISUAL CHARACTER | Grandstand Street-Facing Elevation <ul style="list-style-type: none"> • Two stories • Vernacular • Symmetrical design | | Primary: Dates from the period of significance, highly visible, and retains overall integrity. | Fair to Poor Condition <ul style="list-style-type: none"> • See features below for notable conditions observed on the Grandstand Street-Facing Elevation |

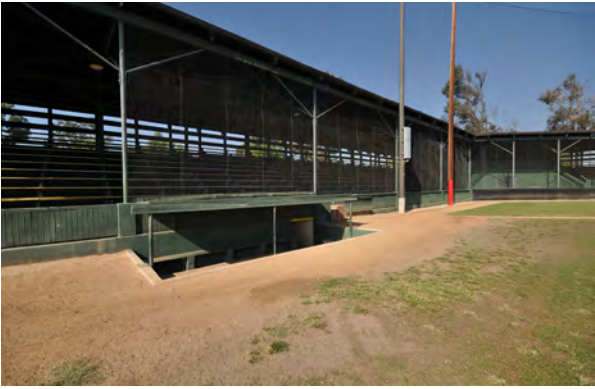
| TYPE | FEATURE | PHOTO (IF APPLICABLE) | IMPORTANCE: REASON | CONDITION |
|---|--|--|--|---|
| | Grandstand Field-Facing Elevation <ul style="list-style-type: none"> • Two stories • Vernacular • Symmetrical design | | Primary: Dates from the period of significance, highly visible, and retains overall integrity. | Fair to Poor Condition <ul style="list-style-type: none"> • See features below for notable conditions observed on the Grandstand Field-Facing Elevation |

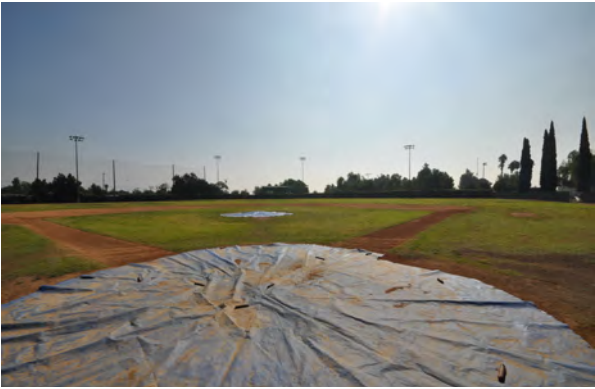
| TYPE | FEATURE | PHOTO (IF APPLICABLE) | IMPORTANCE: REASON | CONDITION |
|---|--|--|--|---|
| | Ball Field <ul style="list-style-type: none"> • Grass infield and outfield • Dirt running paths • Dirt pitchers mound at the center of the infield • Concrete and metal fence surrounds outfield | | Primary: Dates from the period of significance, highly visible, and retains overall integrity. | Good Condition <ul style="list-style-type: none"> • No notable conditions observed |

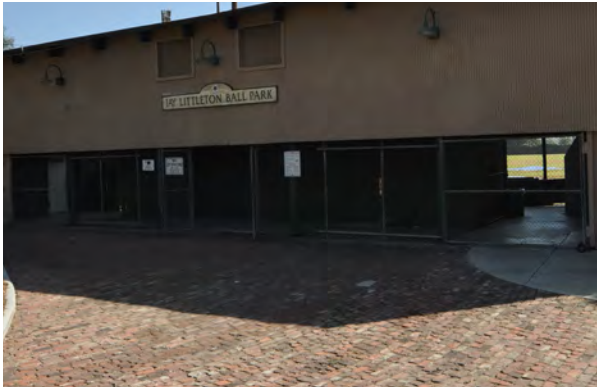
| TYPE | FEATURE | PHOTO (IF APPLICABLE) | IMPORTANCE: REASON | CONDITION |
|---|--|--|---|--|
| OVERALL VISUAL CHARACTER | <p>Main Entrance Configuration</p> <ul style="list-style-type: none"> • First story • Grandstand street-facing elevation • Large rectangular opening • Wood frame • Metal chain-link gate • Brick paved path | | <p>Primary: Dates from the period of significance, highly visible, and retains overall integrity.</p> | <p>Fair Condition</p> <ul style="list-style-type: none"> • Cracking and checking observed at wood posts to either side of the main entrance |

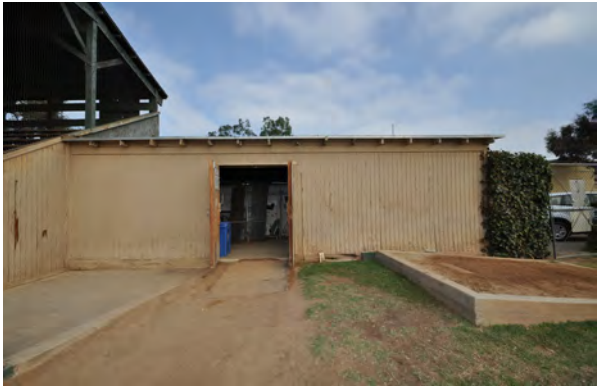
| TYPE | FEATURE | PHOTO (IF APPLICABLE) | IMPORTANCE: REASON | CONDITION |
|---|---|--|--|--|
| OVERALL VISUAL CHARACTER | East Utility Shed <ul style="list-style-type: none"> • East of the east wing • Rectangular massing • Shed roof • Wood siding | | Not: Post dates period of significance. | Not Applicable <ul style="list-style-type: none"> • Non-original utility shed added to the east elevation |

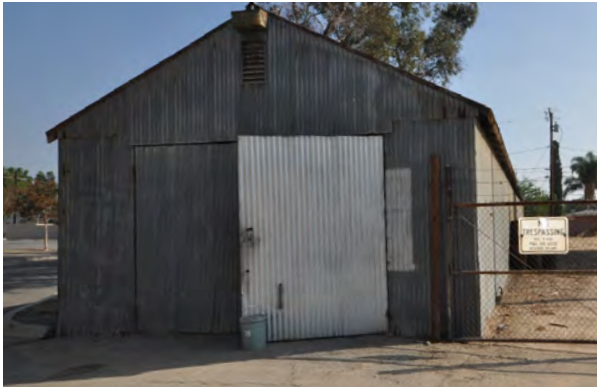
| TYPE | FEATURE | PHOTO (IF APPLICABLE) | IMPORTANCE: REASON | CONDITION |
|---|---|--|--|--|
| | North Utility Shed <ul style="list-style-type: none"> • North of the east wing • Rectangular massing • Gable roof • Corrugated metal siding | | Not: Post dates period of significance. | Not Applicable <ul style="list-style-type: none"> • Non-original utility shed added to the north of the ball field |

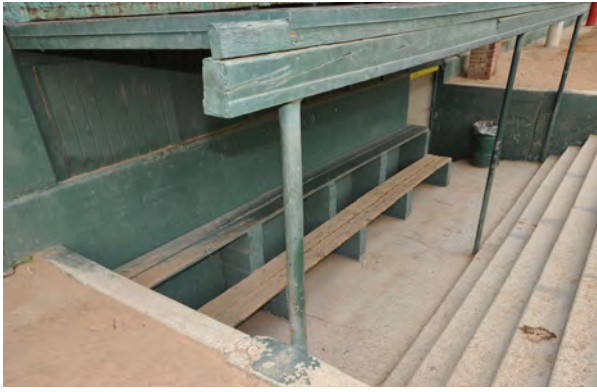
| TYPE | FEATURE | PHOTO (IF APPLICABLE) | IMPORTANCE: REASON | CONDITION |
|---|---|--|---|---|
| EXTERIOR MATERIALS AND CRAFTSMANSHIP | Metal <ul style="list-style-type: none"> • All elevations • Structural members • Window infill • Handrails • Fencing | | Not: Post dates period of significance. | Not Applicable <ul style="list-style-type: none"> • Non-original metal features added |

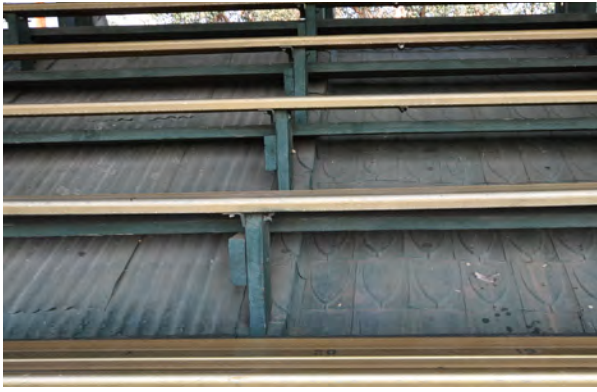
| TYPE | FEATURE | PHOTO (IF APPLICABLE) | IMPORTANCE: REASON | CONDITION |
|---|---|--|---|---|
| | Corrugated metal <ul style="list-style-type: none"> • Roof sheathing | | Not: Post dates period of significance. | Not Applicable <ul style="list-style-type: none"> • Original wood sheathing likely removed and replaced with existing corrugated metal |

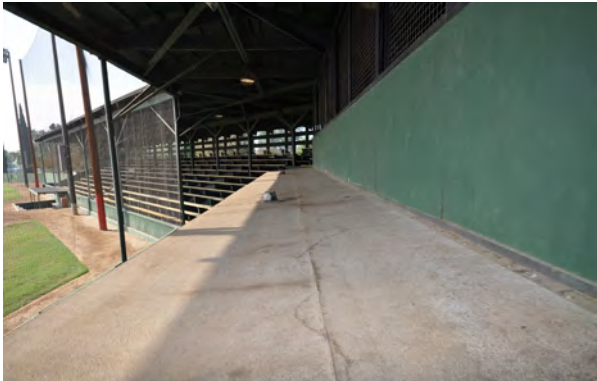
| TYPE | FEATURE | PHOTO (IF APPLICABLE) | IMPORTANCE: REASON | CONDITION |
|---|---|--|---|---|
| | Asphalt <ul style="list-style-type: none"> • Roof | | Not: Post dates period of significance. | Not Applicable <ul style="list-style-type: none"> • Non-original roofing material added |

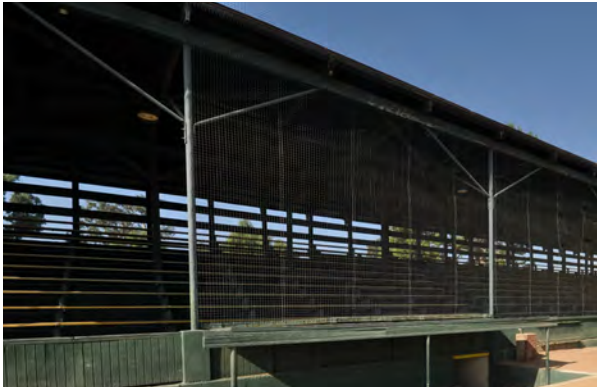
| TYPE | FEATURE | PHOTO (IF APPLICABLE) | IMPORTANCE: REASON | CONDITION |
|---|---|---|--|--|
| EXTERIOR MATERIALS AND CRAFTSMANSHIP | Grandstand Roof Round Columns <ul style="list-style-type: none"> • Grandstand field-facing elevation • Center, south, and east wings • Metal post • Concrete footing | | Not: Post dates period of significance. | Not Applicable <ul style="list-style-type: none"> • Original round columns removed and replaced with existing columns |

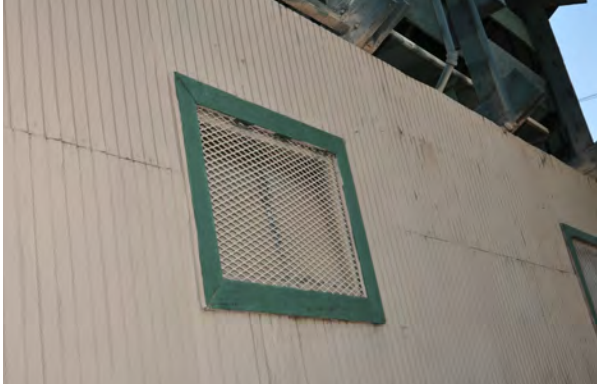
| TYPE | FEATURE | PHOTO (IF APPLICABLE) | IMPORTANCE: REASON | CONDITION |
|---|---|--|---|--|
| EXTERIOR MATERIALS AND CRAFTSMANSHIP | Grandstand Street-Facing Elevation Window Infill <ul style="list-style-type: none"> • Second story • Center, south, and east wings • Metal grate infill | | Not: Post dates period of significance. | Not Applicable <ul style="list-style-type: none"> • Original window infill likely removed and replaced with existing metal grates |

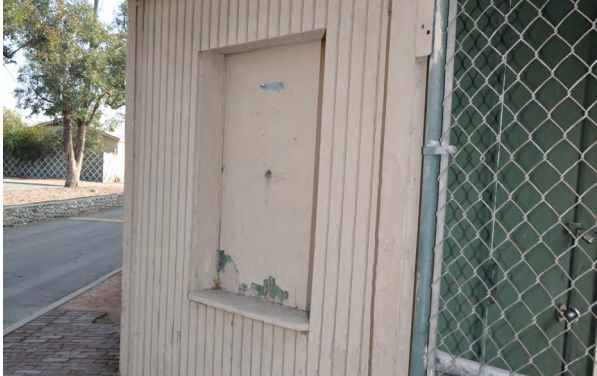
| TYPE | FEATURE | PHOTO (IF APPLICABLE) | IMPORTANCE: REASON | CONDITION |
|---|---|--|---|--|
| | Grandstand Street-Facing Elevation Ticket Window Infill <ul style="list-style-type: none"> • First story • Center section • Wood plank | | Secondary: Dates from the period of significance, but utilitarian feature that retains overall integrity, | Fair Condition <ul style="list-style-type: none"> • Peeling and deteriorating paint observed throughout • Cracking and checking observed |

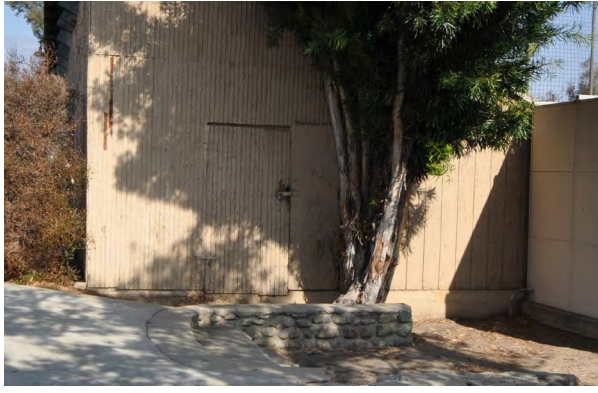
| TYPE | FEATURE | PHOTO (IF APPLICABLE) | IMPORTANCE: REASON | CONDITION |
|---|--|--|---|--|
| | Grandstand Street-Facing Elevation Non-Original Secondary Entrance Doors <ul style="list-style-type: none"> • First story • South and east wings • Located at east and south ends of grandstand • Plywood doors covered with beadboard siding | | Not: Post dates period of significance. | Not Applicable <ul style="list-style-type: none"> • Non-original doors likely added |

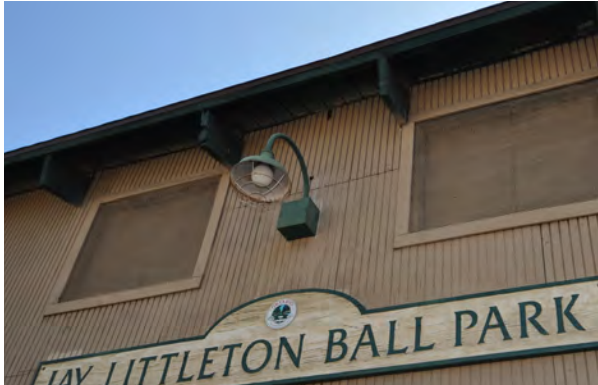
| TYPE | FEATURE | PHOTO (IF APPLICABLE) | IMPORTANCE: REASON | CONDITION |
|---|--|--|---|--|
| | Grandstand Street-Facing Elevation Light Fixtures <ul style="list-style-type: none"> • Second story • All elevations • Center, south, and east wings • Metal | | Not: Post dates period of significance. | Not Applicable <ul style="list-style-type: none"> • Original light fixtures removed and replaced with existing light fixtures |

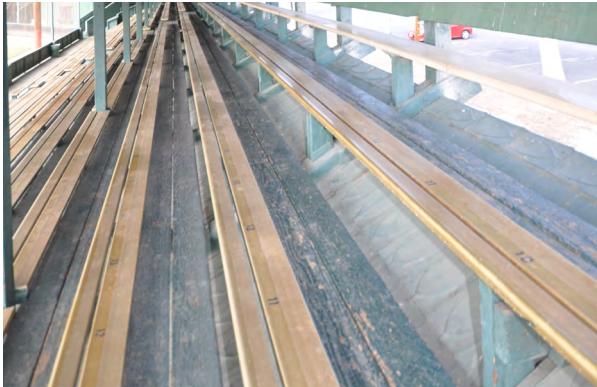
| TYPE | FEATURE | PHOTO (IF APPLICABLE) | IMPORTANCE: REASON | CONDITION |
|---|---|--|--|--|
| | Grandstand Field-Facing Elevation Grandstand Benches <ul style="list-style-type: none"> • First and second stories • South and east wings • Metal | | Not: Post dates period of significance. | Not Applicable <ul style="list-style-type: none"> • Original wood plank seating removed and replaced with existing metal bleachers |

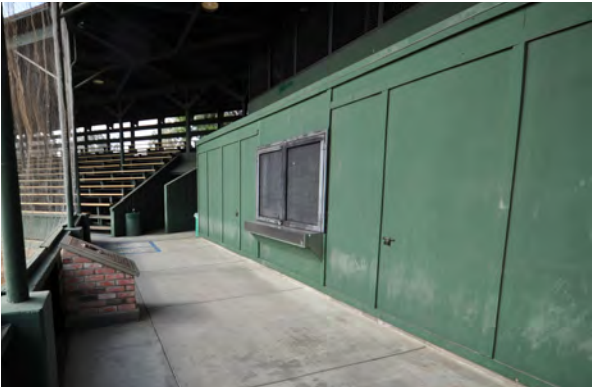
| TYPE | FEATURE | PHOTO (IF APPLICABLE) | IMPORTANCE: REASON | CONDITION |
|---|---|--|--|---|
| | Grandstand Field-Facing Elevation Board and Batten Siding <ul style="list-style-type: none"> • First story • Center section • Wood | | Not: Post dates period of significance. | Not Applicable <ul style="list-style-type: none"> • Original siding removed and replaced with existing board-and-batten siding |

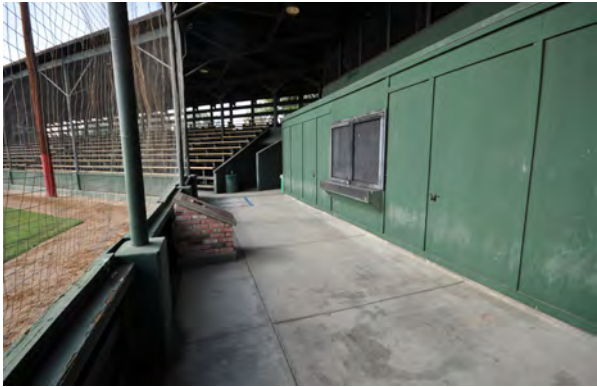
| TYPE | FEATURE | PHOTO (IF APPLICABLE) | IMPORTANCE: REASON | CONDITION |
|---|---|--|--|--|
| EXTERIOR MATERIALS AND CRAFTSMANSHIP | Grandstand Field-Facing Elevation Concession Stand <ul style="list-style-type: none"> • First story • Center section • Metal frame and security gates • Rectangular opening | | Not: Post dates period of significance. | Not Applicable <ul style="list-style-type: none"> • Concession stand enlarged and non-original window opening added |

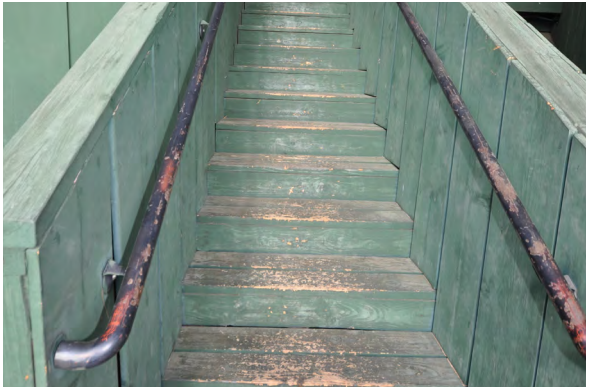
| TYPE | FEATURE | PHOTO (IF APPLICABLE) | IMPORTANCE: REASON | CONDITION |
|---|---|--|--|--|
| | Grandstand Field-Facing Elevation Press Box Stair Hand Rail <ul style="list-style-type: none"> • First and second stories • Center section • Metal | | Not: Post dates period of significance. | Not Applicable <ul style="list-style-type: none"> • Non-original metal handrail added |

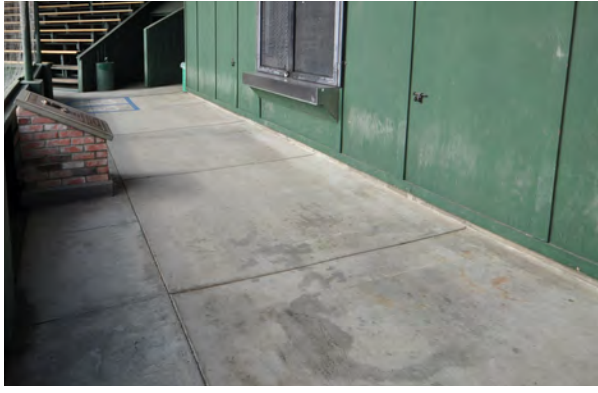
| TYPE | FEATURE | PHOTO (IF APPLICABLE) | IMPORTANCE: REASON | CONDITION |
|---|---|--|--|--|
| | Grandstand Field-Facing Elevation Non-Original Sidewalk <ul style="list-style-type: none"> • First story • Center section • Concrete | | Not: Post dates period of significance. | Not Applicable <ul style="list-style-type: none"> • Original concrete sidewalk removed and replaced with existing sidewalk |

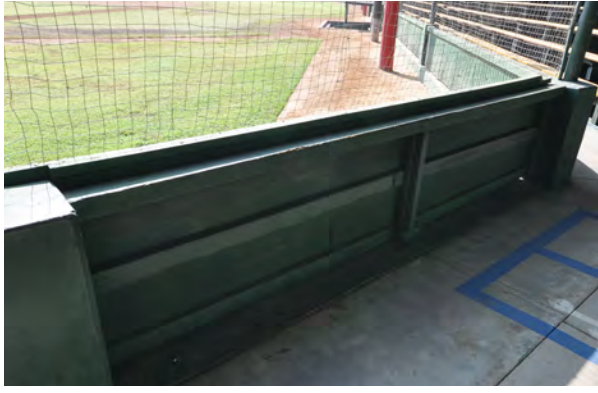
| TYPE | FEATURE | PHOTO (IF APPLICABLE) | IMPORTANCE: REASON | CONDITION |
|---|---|--|--|--|
| | Grandstand Field-Facing Elevation Center Section Field Fence <ul style="list-style-type: none"> • Plywood | | Not: Post dates period of significance. | Not Applicable <ul style="list-style-type: none"> • Original fence at center section removed and replaced with existing fence |

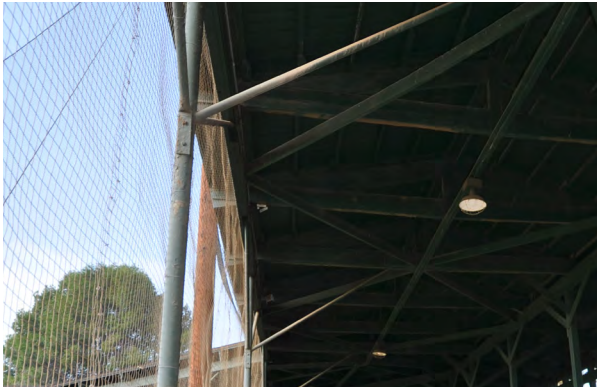
| TYPE | FEATURE | PHOTO (IF APPLICABLE) | IMPORTANCE: REASON | CONDITION |
|---|---|--|---|--|
| | Grandstand Field-Facing Elevation Netting <ul style="list-style-type: none"> • First and second stories • Center, south, and east wings • Nylon • Wood poles | | Not: Post dates period of significance. | Not Applicable <ul style="list-style-type: none"> • Non-original netting added |

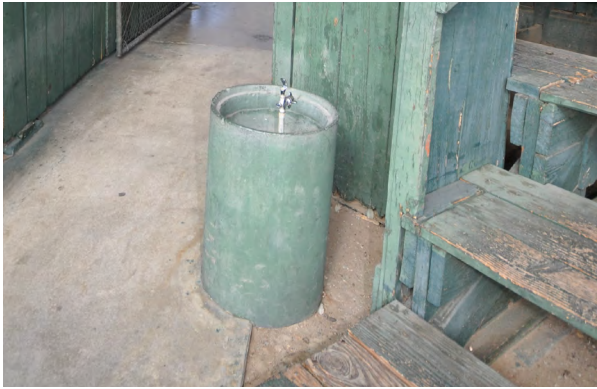
| TYPE | FEATURE | PHOTO (IF APPLICABLE) | IMPORTANCE: REASON | CONDITION |
|---|---|--|---|--|
| | Grandstand Field-Facing Elevation Original Water Fountains <ul style="list-style-type: none"> • First story • Center section • Concrete | | Secondary: Dates from the period of significance, but utilitarian feature that retains overall integrity, | Good Condition <ul style="list-style-type: none"> • No notable conditions observed |

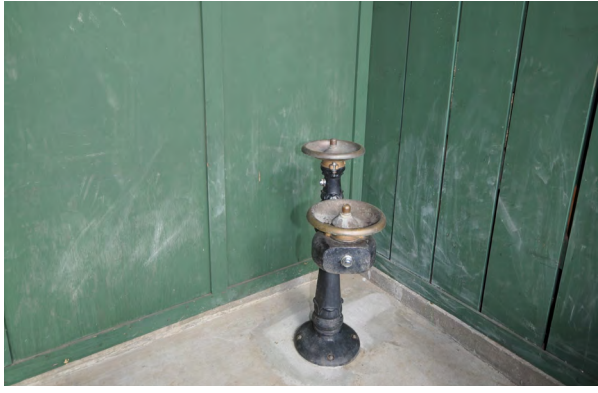
| TYPE | FEATURE | PHOTO (IF APPLICABLE) | IMPORTANCE: REASON | CONDITION |
|---|--|--|--|---|
| EXTERIOR MATERIALS AND CRAFTSMANSHIP | Grandstand Field-Facing Elevation Non-Original Water Fountains <ul style="list-style-type: none"> • First story • Center section • Metal | | Not: Post dates period of significance. | Not Applicable <ul style="list-style-type: none"> • Non-original water fountain added |

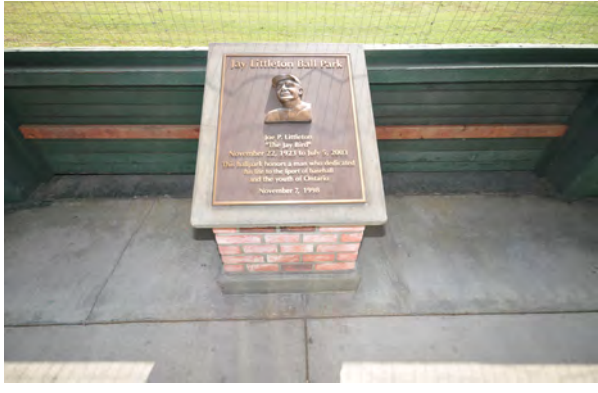
| TYPE | FEATURE | PHOTO (IF APPLICABLE) | IMPORTANCE: REASON | CONDITION |
|---|--|--|--|---|
| | Grandstand Field-Facing Elevation Memorial Plaque <ul style="list-style-type: none"> • First story • Center section • Brick plinth • Metal plaque | | Not: Post dates period of significance. | Not Applicable <ul style="list-style-type: none"> • Non-original memorial plaque added |

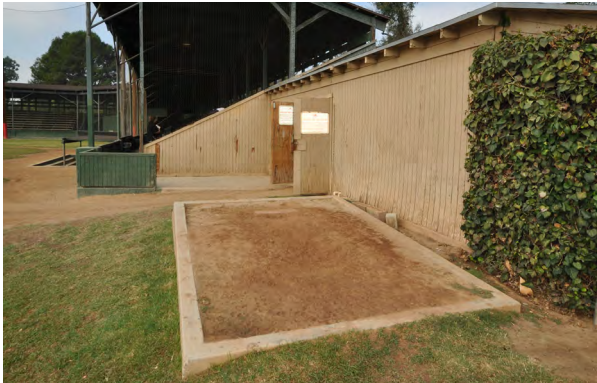
| TYPE | FEATURE | PHOTO (IF APPLICABLE) | IMPORTANCE: REASON | CONDITION |
|---|---|--|---|---|
| | Ball Field Batting Practice Areas <ul style="list-style-type: none"> Located to the south and east of the grandstand Concrete curb | | Not: Post dates period of significance, | Not Applicable <ul style="list-style-type: none"> Non-original batting practice areas added |

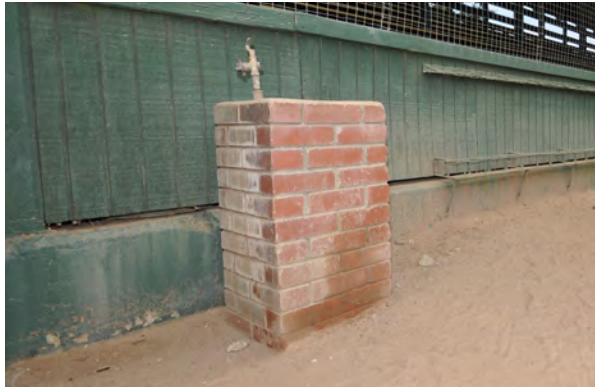
| TYPE | FEATURE | PHOTO (IF APPLICABLE) | IMPORTANCE: REASON | CONDITION |
|---|--|--|--|---|
| EXTERIOR MATERIALS AND CRAFTSMANSHIP | Ball Field Water Fountains <ul style="list-style-type: none"> • Located adjacent to dugouts • Brick | | Not: Post dates period of significance. | Not Applicable <ul style="list-style-type: none"> • Non-original water fountains added |

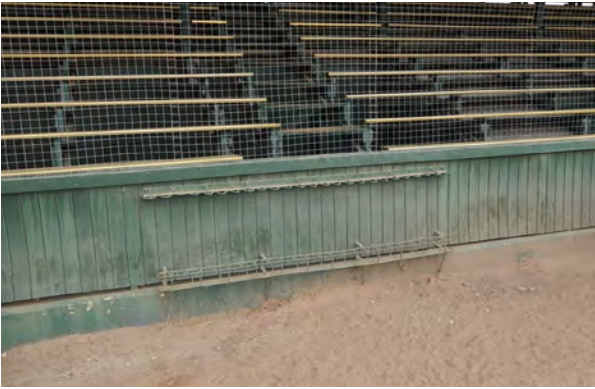
| TYPE | FEATURE | PHOTO (IF APPLICABLE) | IMPORTANCE: REASON | CONDITION |
|---|--|--|--|---|
| | Ball Field Bat Racks <ul style="list-style-type: none"> • Located adjacent to dugouts • Metal | | Not: Post dates period of significance. | Not Applicable <ul style="list-style-type: none"> • Non-original bat racks added |

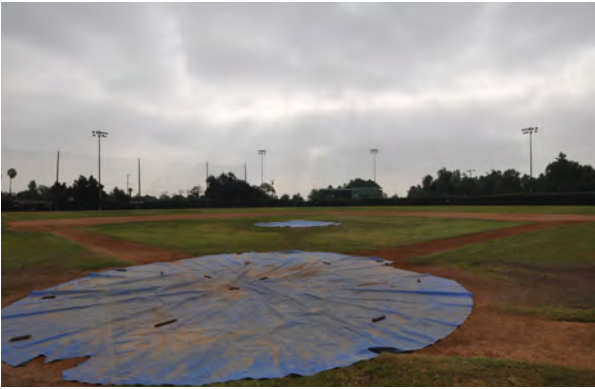
| TYPE | FEATURE | PHOTO (IF APPLICABLE) | IMPORTANCE: REASON | CONDITION |
|---|--|--|--|---|
| | Ball Field Infield <ul style="list-style-type: none"> • Grass | | Primary: Dates from the period of significance, highly visible, and retains overall integrity. | Good Condition <ul style="list-style-type: none"> • No notable conditions observed |

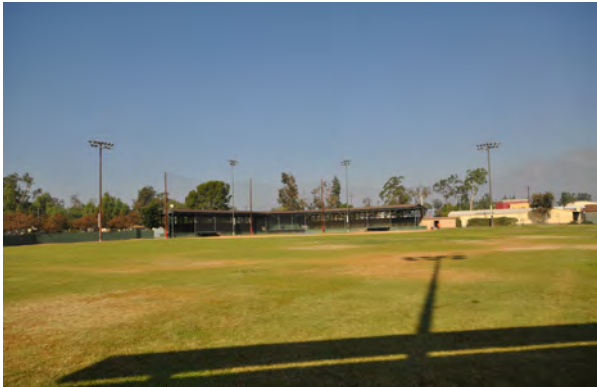
| TYPE | FEATURE | PHOTO (IF APPLICABLE) | IMPORTANCE: REASON | CONDITION |
|---|---|--|--|--|
| | Ball Field Outfield <ul style="list-style-type: none"> Grass | | Primary: Dates from the period of significance, highly visible, and retains overall integrity. | Good Condition <ul style="list-style-type: none"> No notable conditions observed |

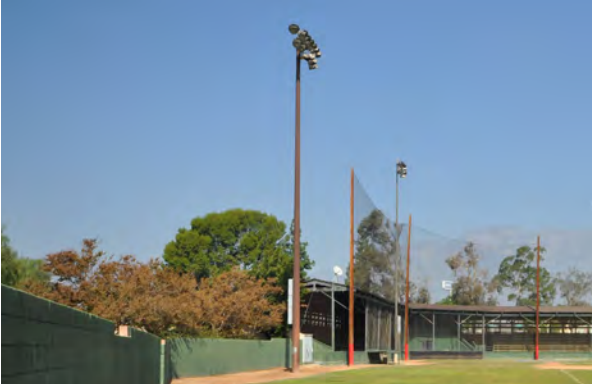
| TYPE | FEATURE | PHOTO (IF APPLICABLE) | IMPORTANCE: REASON | CONDITION |
|---|---|---|--|---|
| EXTERIOR MATERIALS AND CRAFTSMANSHIP | Ball Field Lights <ul style="list-style-type: none"> Regularly spaced along the boundary of the ball field Metal poles Downlights | | Not: Post dates period of significance. | Not Applicable <ul style="list-style-type: none"> Non-original ball field lights added |

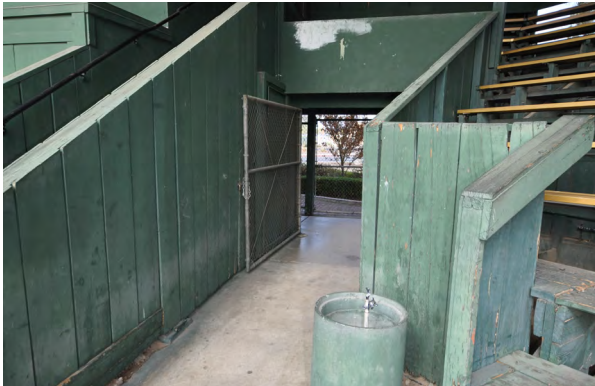
| TYPE | FEATURE | PHOTO (IF APPLICABLE) | IMPORTANCE: REASON | CONDITION |
|---|--|--|--|---|
| | Entrance Tunnels – Space, Features, & Finishes <ul style="list-style-type: none"> • First story • Located to the north and south of the entrance vestibule • Rectangular opening • Wood plank siding • Concrete walkway | | Primary: Dates from the period of significance, highly visible, and retains overall integrity. | Fair to Poor Condition <ul style="list-style-type: none"> • See Grandstand Ball Field Elevation, Wood Plank Siding for notable conditions observed |

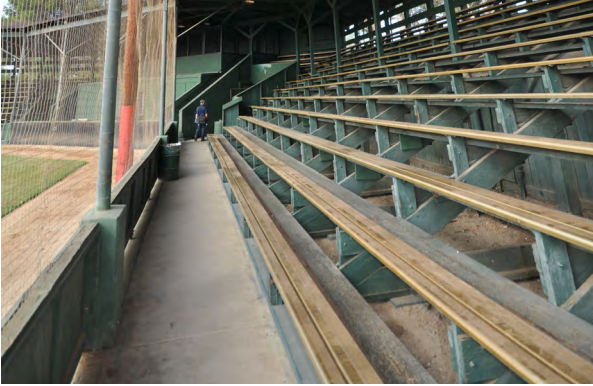
| TYPE | FEATURE | PHOTO (IF APPLICABLE) | IMPORTANCE: REASON | CONDITION |
|---|---|--|--|--|
| INTERIOR SPACES, FEATURES, AND FINISHES | Grandstand Walkways – Space, Features, & Finishes <ul style="list-style-type: none"> • First story • Located along the grandstand seating • Concrete | | Primary: Dates from the period of significance, highly visible, and retains overall integrity. | Good Condition <ul style="list-style-type: none"> • See Grandstand Field-Facing Elevation for notable conditions observed |

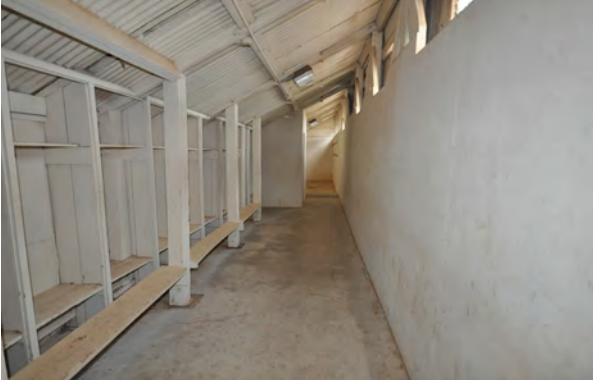
| TYPE | FEATURE | PHOTO (IF APPLICABLE) | IMPORTANCE: REASON | CONDITION |
|---|---|--|--|--|
| | Locker Rooms – Space, Features, & Finishes <ul style="list-style-type: none"> • First story • Located to the west and north of the locker room tunnels • Corrugated metal ceiling • Plywood walls • Wood locker partitions • Concrete floor | | Secondary: Dates from the period of significance and retains integrity, but not originally intended for public access. | Fair Condition <ul style="list-style-type: none"> • Non-original plywood walls added • Weathering of wood observed throughout • Cracking and checking observed at select locations • Material loss observed at plywood walls • Missing, loose, and displaced elements of lockers observed at select locations |

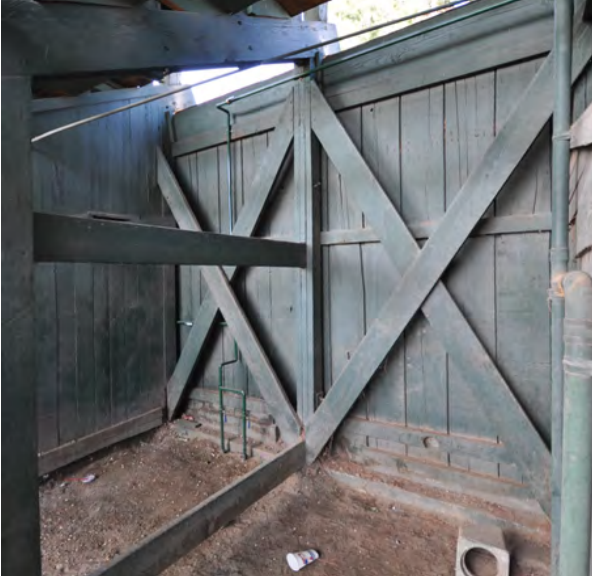
| TYPE | FEATURE | PHOTO (IF APPLICABLE) | IMPORTANCE: REASON | CONDITION |
|---|---|---|--|---|
| INTERIOR SPACES, FEATURES, AND FINISHES | Grandstand Base – Space, Features, & Finishes <ul style="list-style-type: none"> • First story • Located beneath grandstand seating • Exposed structural members • Wood plank siding • Dirt floor | | Secondary: Dates from the period of significance and retains integrity, but not originally intended for public access. | Fair to Poor Condition <ul style="list-style-type: none"> • See above features for notable conditions observed |

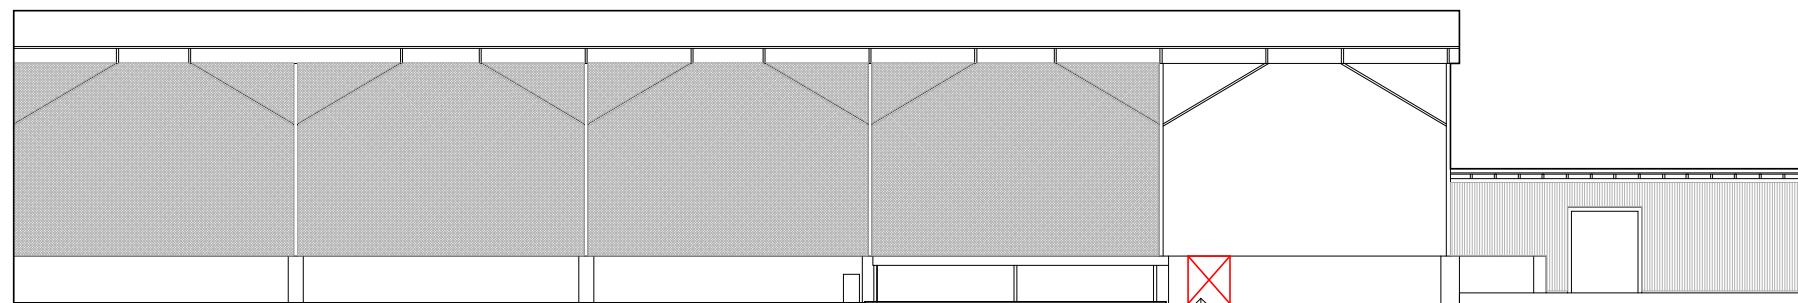
INTERIOR-SOUTH
ELEVATION DEMO
② 1/8" = 1'-0"

(N) OPENING FOR GATE
TO (N) TEAM PLAYER
SEATING AREA

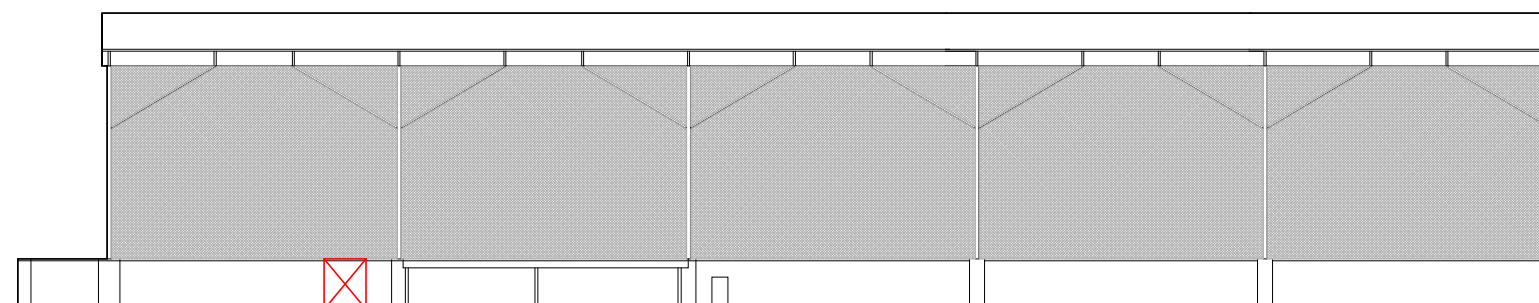
INTERIOR-EAST ELEVATION
DEMO
① 1/8" = 1'-0"

(N) OPENING FOR GATE
TO (N) TEAM PLAYER
SEATING AREA
